Sewage Treatment System Impact Monitoring Program

Volume 1: Main Report
Data Report 2022-23

Report version: STSIMP Data Report 2022-23 Volume 1 final

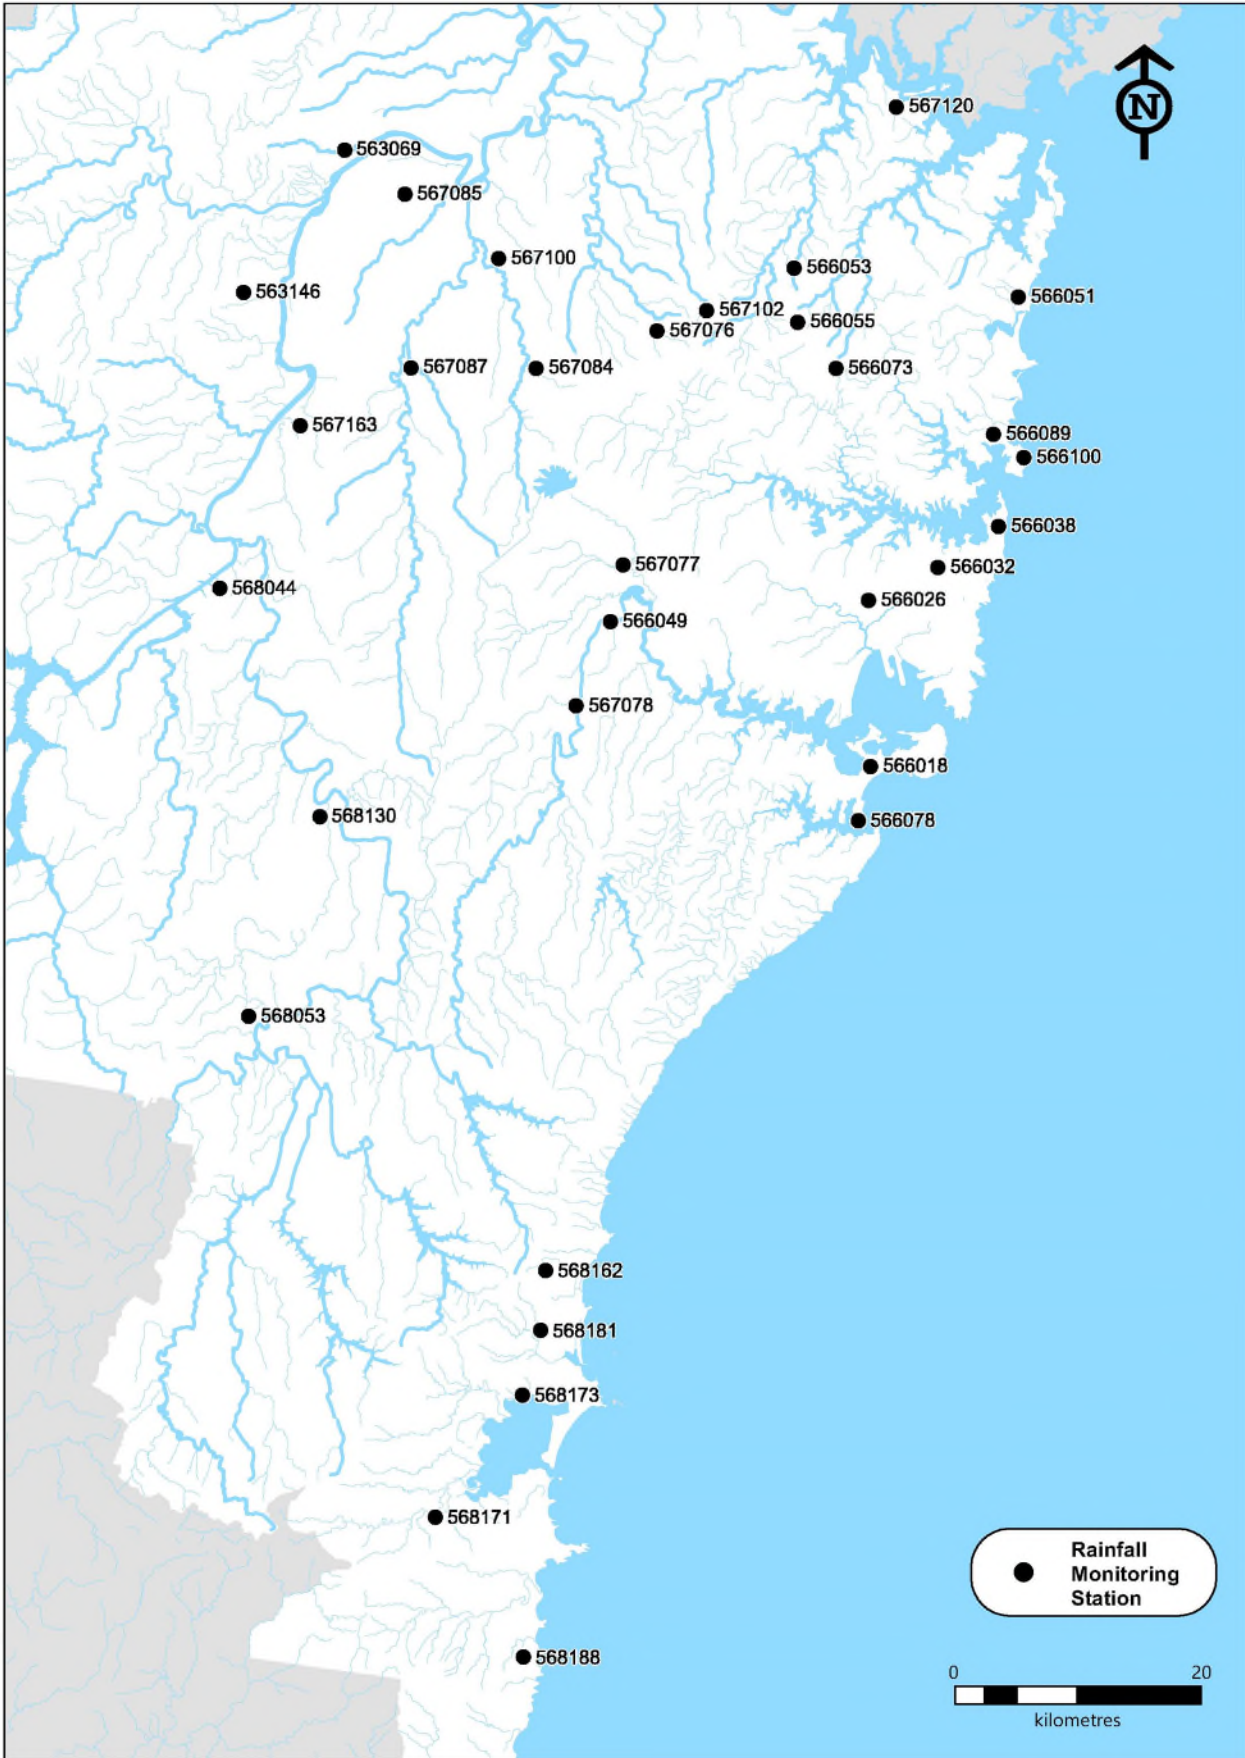
Figure 3-2 Rainfall gauging stations used for assessing the wastewater data

Daily average rainfall data for the 35 gauging stations are used to generate WRRF catchment specific trends in rainfall in comparison to wastewater inflows and discharges (Table 3-1 and Figure 3-2). These data are provided as an electronic appendix (Appendix H-1)

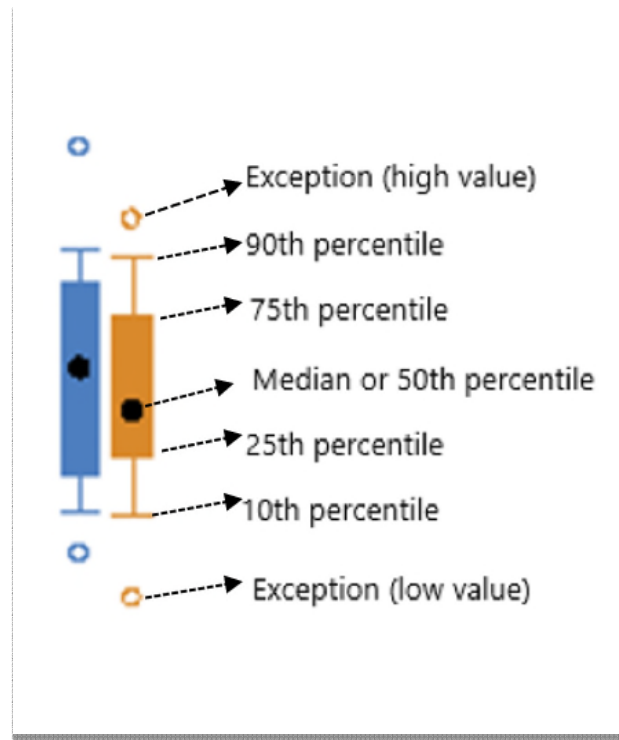
Figure 3-3 Example box plot for presenting water quality at upstream and downstream site pairs

Each water quality analyte (nutrients, other physico-chemical analytes, phytoplankton as chlorophyll-a, biovolume/ species counts) are plotted as box plots for the 18 paired sites (upstream and downstream) to understand the generalised trends and differences between upstream and downstream sites for each WRRF and catchment (tributary/ river). An example box plot for these paired sites is shown in (Figure 3-3). The box plots graphed the 25th percentile value, median/50th percentile (dot) and 75th percentile values. The whiskers point to the 10th (bottom line) and 90th (top line) percentile values. Blue and orange circles outside of whiskers are outliers. These box plots also contain annotated guidelines as horizontal lines for comparison when available (Table 3-6).

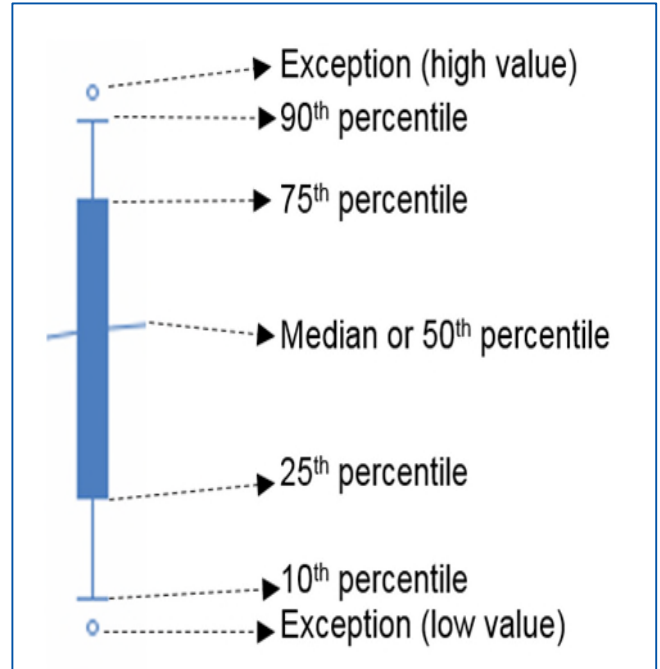
Figure 3-4 Example box plot for the single water quality site

If the 2022-23 data was significantly different from the previous nine years or exceeded guideline/alert limits, then these were identified as exceptions and presented in the main body of this report (Volume 1, Chapter 5.1). These exceptions could either denote improvement or deterioration in water quality. All box plots for these single sites are included in Appendix C (Volume 2).

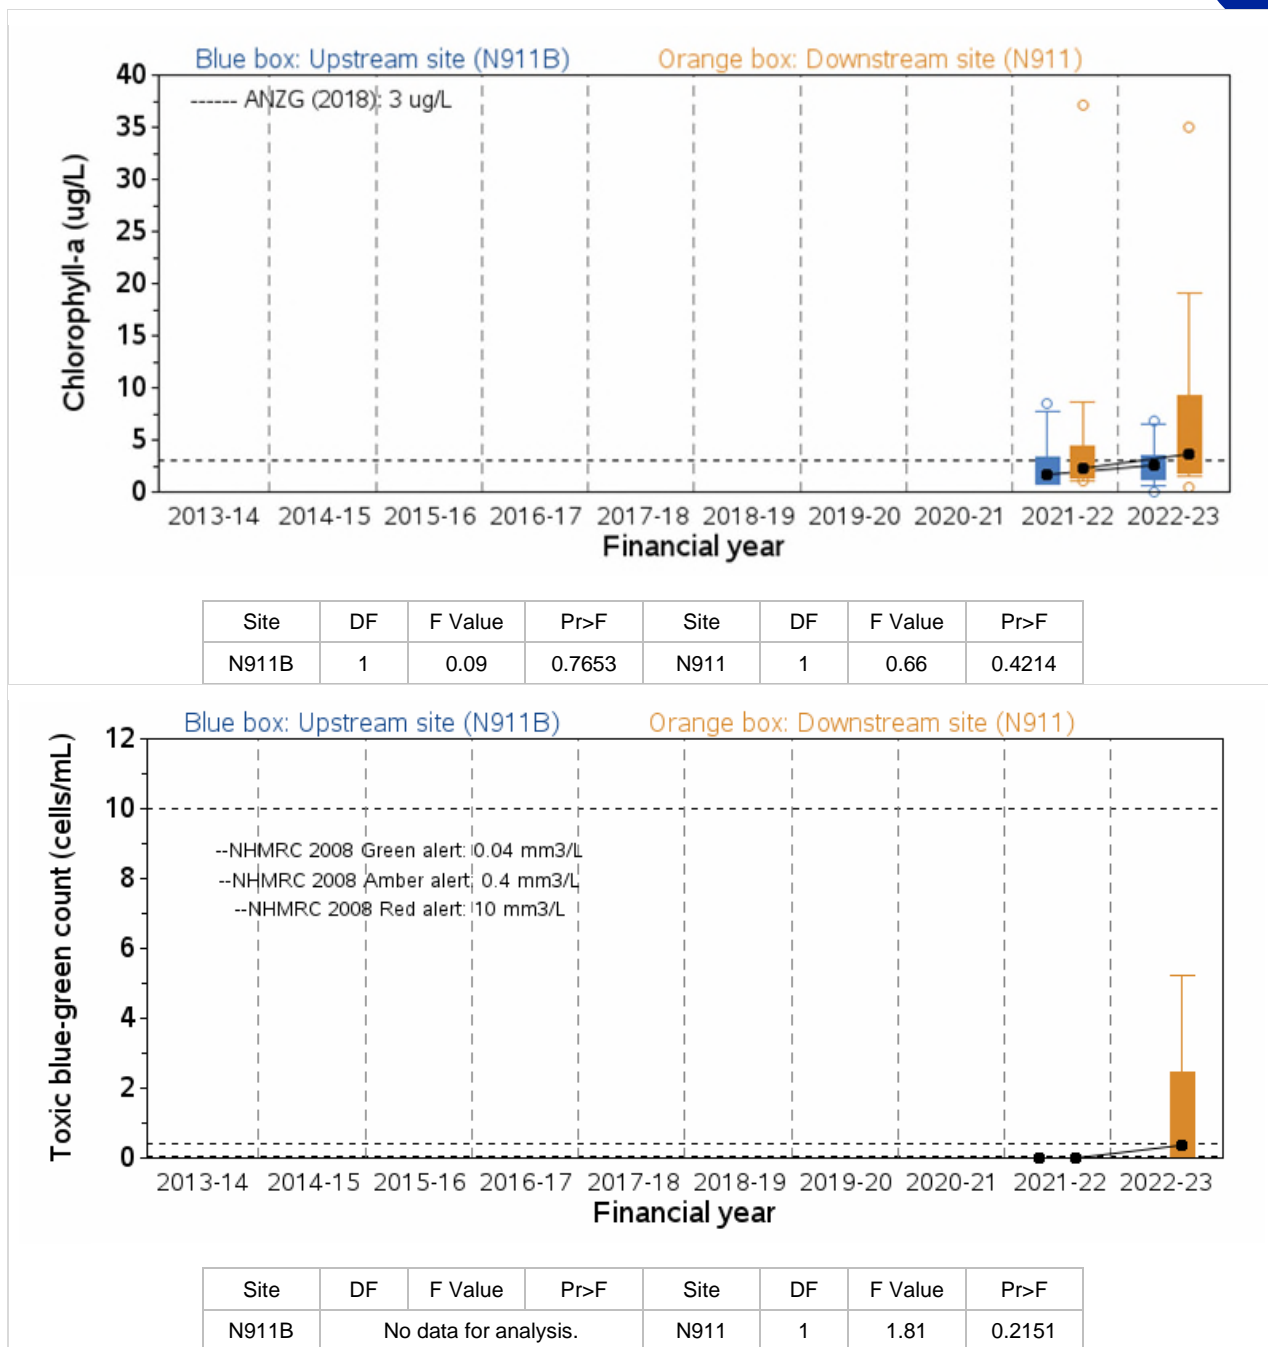
Figure 4-4 Phytoplankton as chlorophyll-a, biovolume and species counts exception plots, upstream and downstream of Picton WRRF

Four of the 17 samples collected from N91 qualified for a phytoplankton biovolume and species count as chlorophyll-a were higher than 7.0 µg/L. Potentially toxic taxa *Microcystis* was found in one of the samples on 20 June 2023 (484 cells/mL).

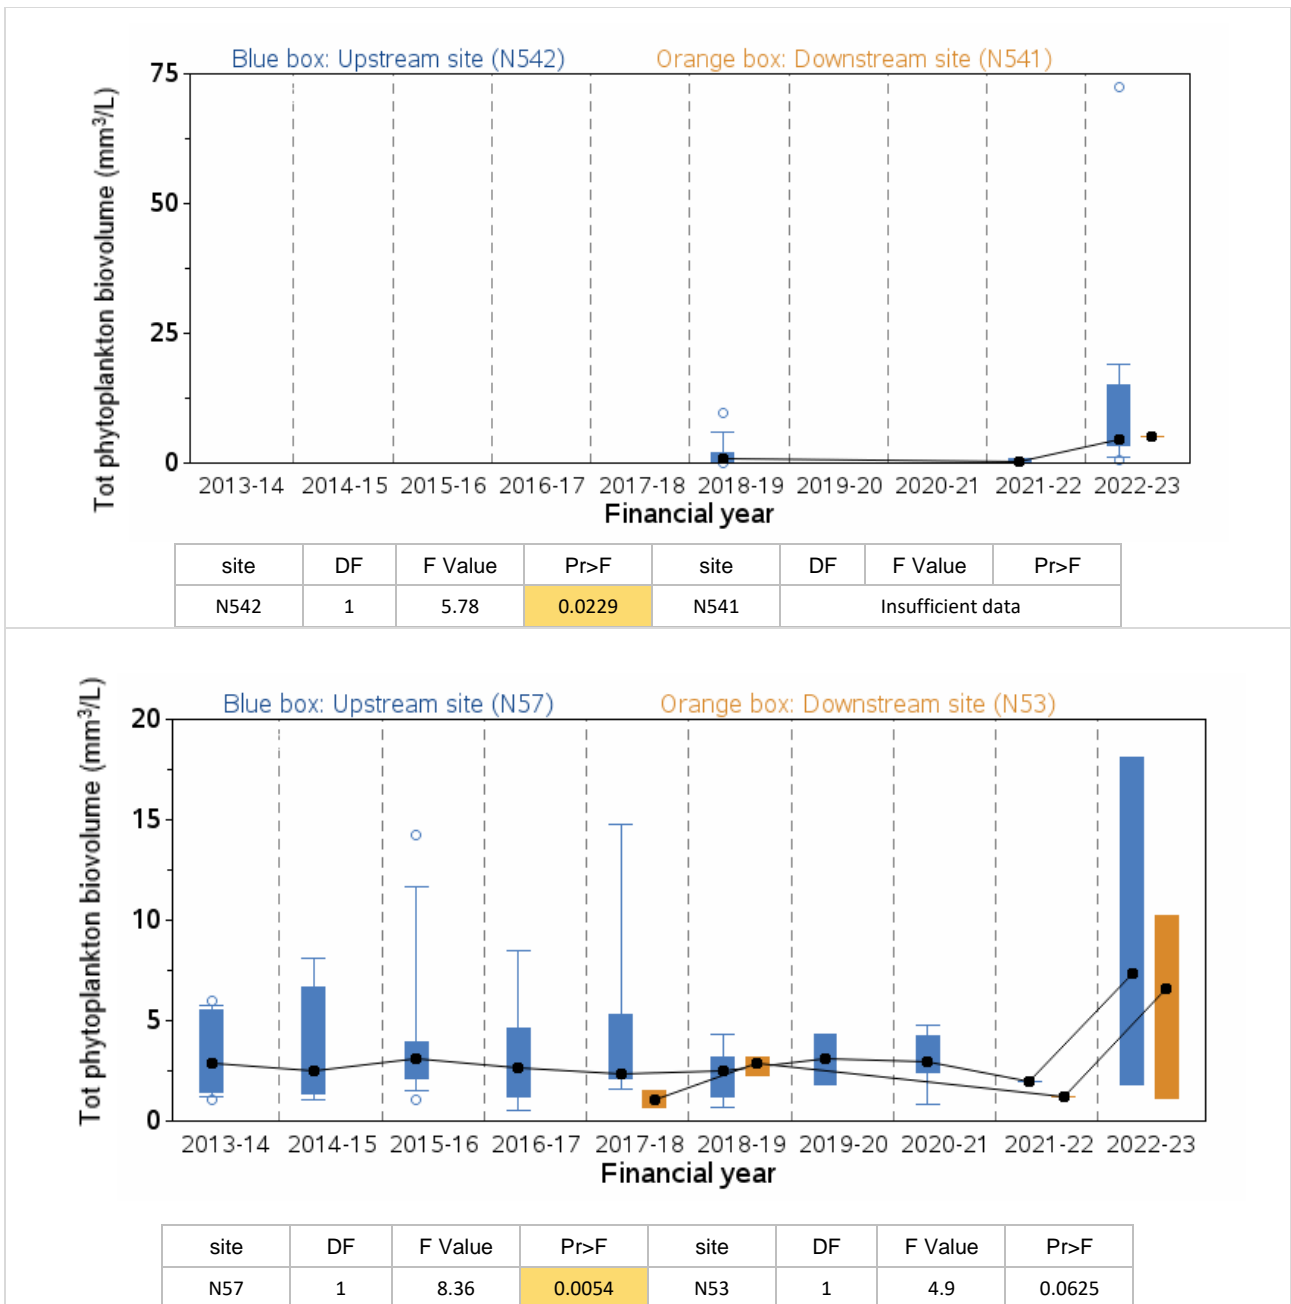
Figure 4-19 Phytoplankton as chlorophyll-a, biovolume and species counts exception plots, upstream and downstream of Penrith WRRF

Three of the 17 samples collected from both upstream and downstream Nepean River site qualified for species counts during January-February 2023. At Penrith Weir (N57, upstream control site), potentially toxic blue-green species counts reached 1,700 cells/mL on 17 February 2023 (*Aphanizomenonaceae* and *Microcystis*) which is within the NHMRC (2008) Amber Alert. No potentially toxic blue green species were found at downstream site (N53).

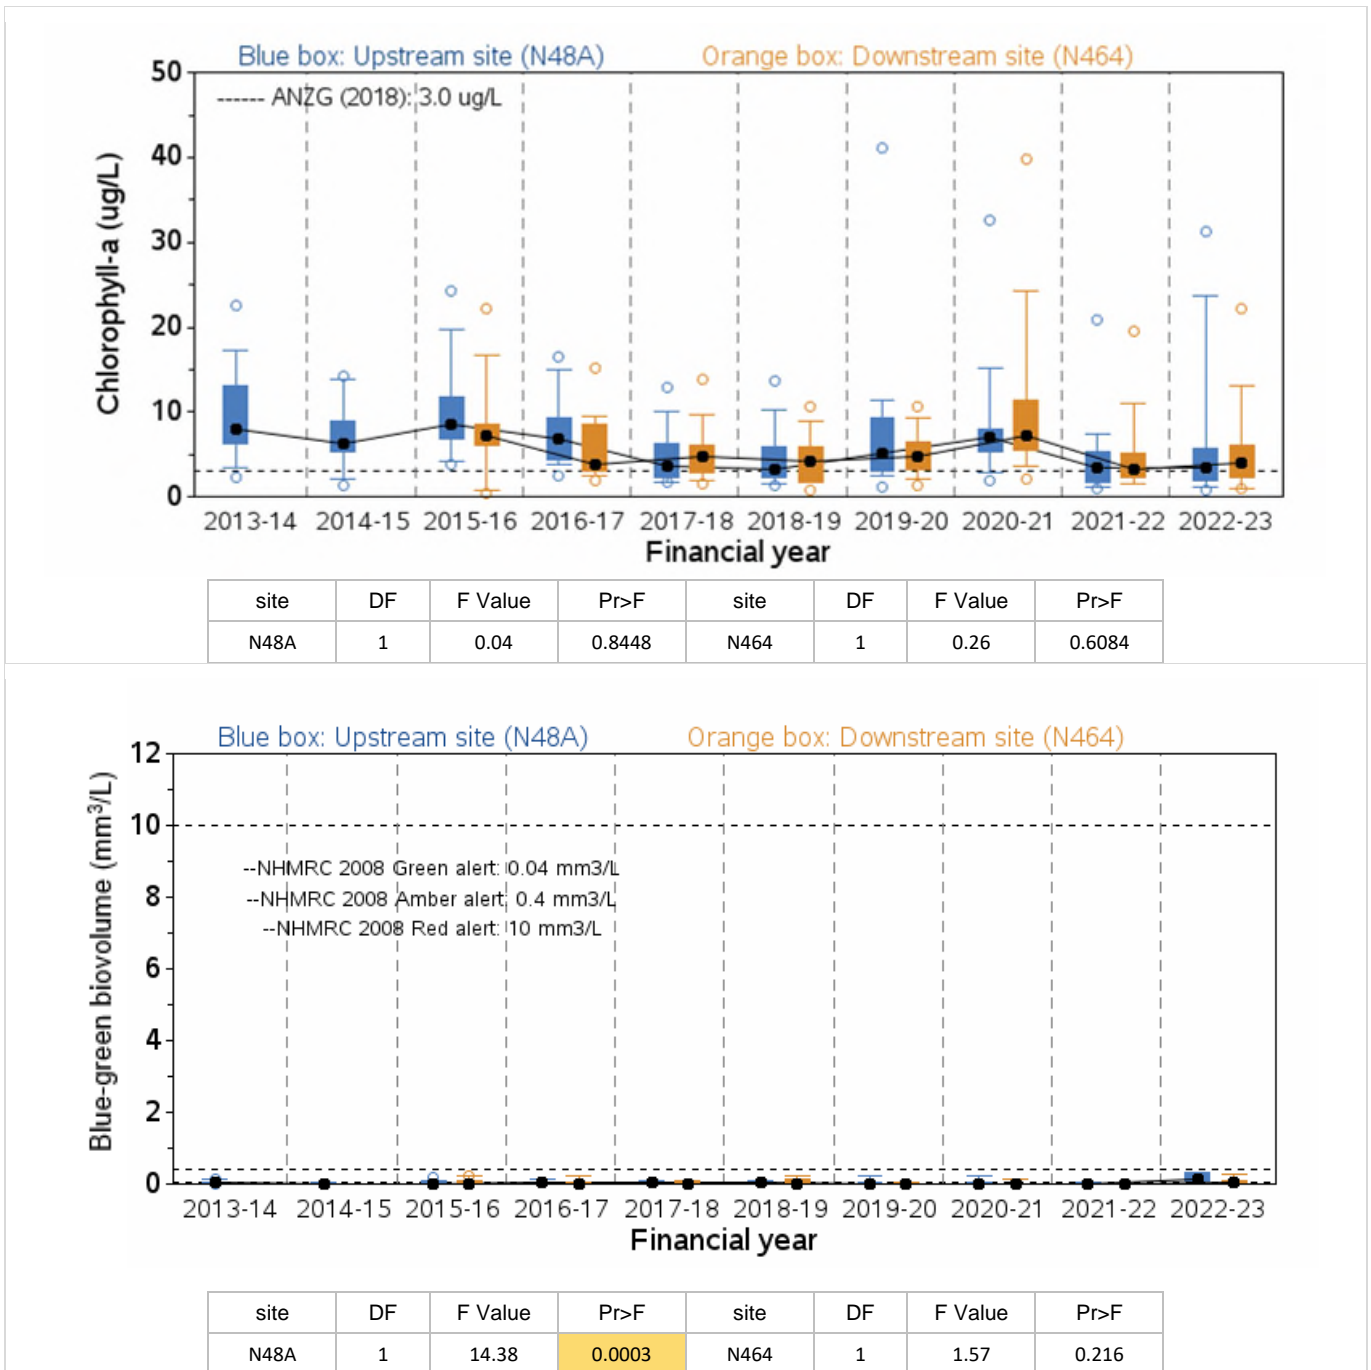
Figure 4-23 Phytoplankton as chlorophyll-a, biovolume and species counts exception plots, upstream and downstream of Winmalee WRRF

For the downstream lagoon site (N464), six of the 17 samples qualified for species counts. Four of these samples contained toxic blue-green taxa (*Aphanizomenonaceae* and *Microcystis*), maximum of 589 cells/mL on 6 March 2023.
